TECHNICAL MEMORANDUM

U.S. NAVAL APPLIED SCIENCE LABORATORY
NAVAL BASE
BROOKLYN I, NEW YORK

REPORT OF INSPECTION AND PROGRESS
IN
APPLICATION OF STELLITE 6B OVERLAYS OF
HIGH POINT (PC(H)-1)

5 FEB 1964

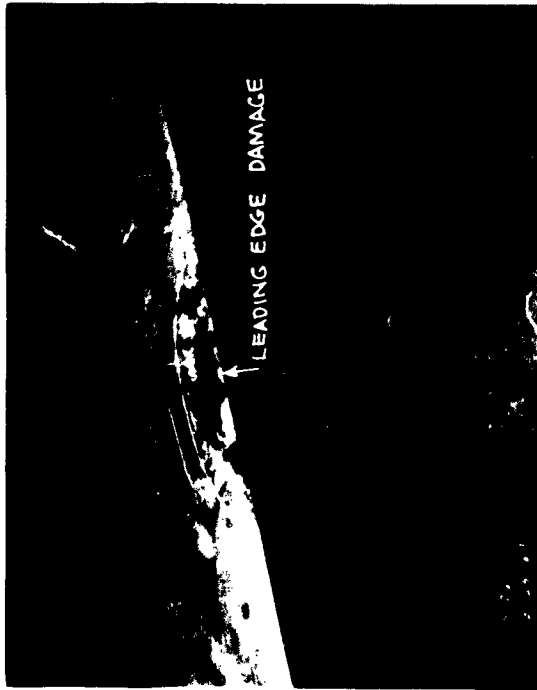
E - Aft foil and port nacelle, forward, underside
Enclosure (7)

(6) The adhesive strength of the polyurethane coating was low, resulting in peeling at the sea water inlets, enclosures (3)B, and (4)D, and at the foil leading edge, enclosure (7)A.

Conditions of Aft Foil, Amidships, Forward Area, and Port Macelle and Foil (Outboard. Forward, Underside)

A - Aft foil, amidships, leading edge coating damage
